Tech Bulletin

Fuel Water Separating Filters

9-37805 & 9-37806

#2010-001

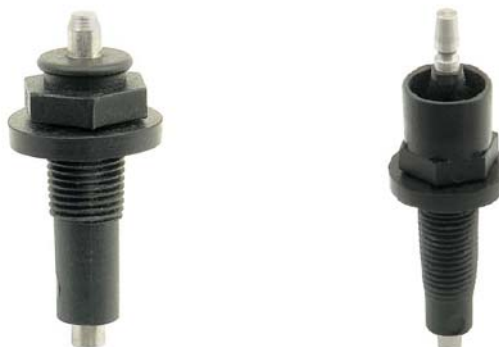
We at Mallory Marine occasionally receive calls concerning alarms or warnings sounding right after installation of our 9-37805 & 9-37806 Fuel Water Separating Filters. The cause of this condition is improper installation of the sensor and rubber spacer.

The rubber spacer is not intended to serve as a seal, but rather a spacer, indicating the proper depth the sensor should thread into the filter housing.

The sensor should thread into the filter housing just far enough for the spacer to contact the housing, not compress the rubber spacer.

Threading the sensor in beyond this point, will compress the spacer, causing the sensor to malfunction. This improper installation will set-off an immediate alarm or other warning that there is water in the filter.

Thread the rubber spacer onto the sensor until it bottoms out on the hex head. There are two different style sensors that have been used depending on the year of the engine (with or without shroud). The installation procedure is the same for either style sensor.
