Tech Bulletin

New & Remanufactured Carburetors

#2010-004

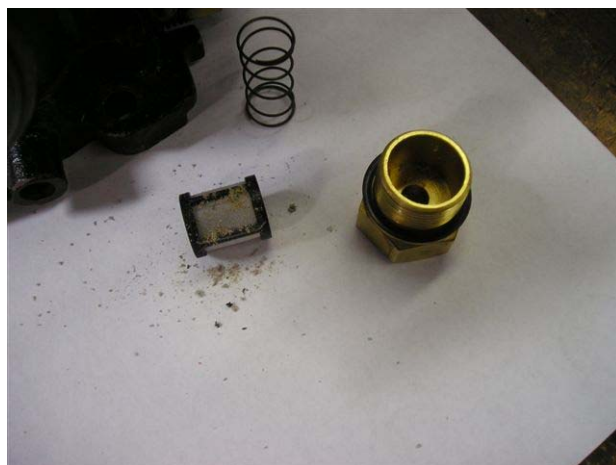
Any amount of dirt, rust, or debris entering the carburetor will cause it to flood and/or malfunction.

Debris removed from a newly installed carburetor, where proper installation procedures were not followed.

Proper carburetor installation procedures mandate flushing the fuel system and replacing all fuel filters before installing a new or remanufactured carburetor.

If not already equipped with a fuel water separator, we also recommended the installation of a Mallory Marine® Fuel Water separator kit at this time.
